# Quality Alert

Part: 21-7253

What: Tank Filler Strainer

Products Affected: Mid-Mount Boom Mowers with tanks located on the Travel Rest

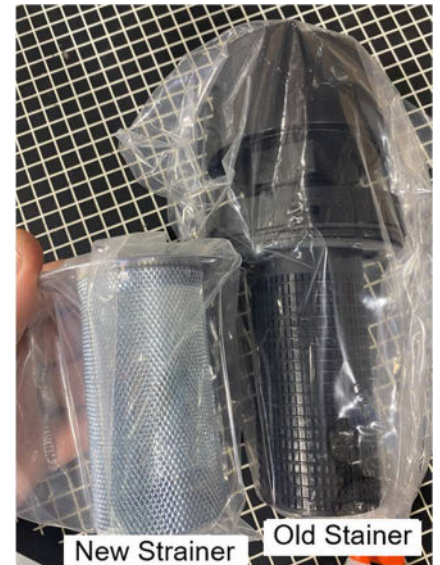
During a review of field performance, it was determined that the original filler strainer material may weaken over time and could be susceptible to cracking or breaking under normal operating conditions.

The updated metal version can be visually distinguished by its silver metallic appearance, whereas the original design is molded black plastic.

As a corrective action, the filler strainer has been redesigned using a more durable metal material. This updated design significantly improves strength and long-term reliability.

- Inspect existing units for the original style strainer
- Replace with the updated metal version where applicable
